## Optimum Window Mfg. Corp.

SCALE 1:3, AS NOTED	DATE: 8/20/03	DRAWN BY: MATT S.	CUSTOMER P.O.#	RE:
SERIES: 7650TDH	DRAWING NUMBER: INSTALL 7650TDH		DIM:	COLOR:
TITLE: Typical conditions for 7650TDH Series Windows			DATE:	GLAZING:
APPROVED AND ACCEPTED BY:

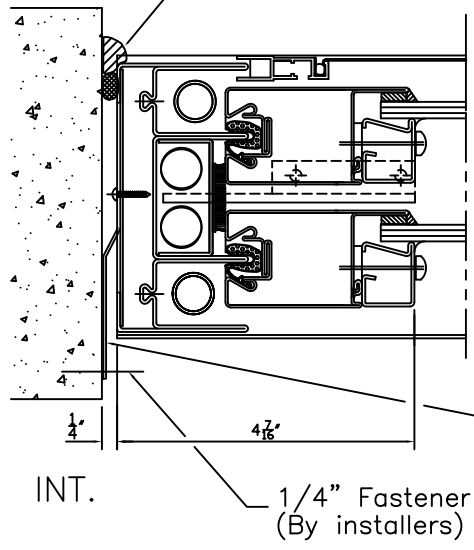
Typical Jamb Condition

16 Gauge Galvanized Steel Installation Strap @ 18" O.C. to be bent & cut & attached in field by installer

Rev. A 12/1/03 wr  
Revised gasket in jamb section.
